Agricultural Watchtowers in Al-Tireh Quarter and 'Ain Qinia Village, Ramallah, Palestine

Article in *International Journal of Architectural Heritage* · January 2012

AGRICULTURAL WATCHTOWERS IN AL-TIREH QUARTER AND 'AIN QINIA VILLAGE, RAMALLAH, PALESTINE

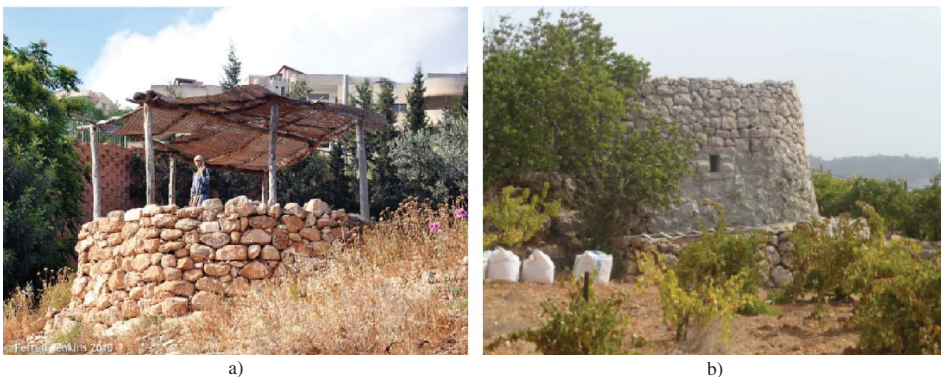
Figure 2. Photographs of forms of agricultural watchtowers in the Palestinian Territories, according to their geographic location: a) an ancient watchtower replica at Nazareth Village, reflecting the general form of a simple seasonal arbor, or *areesh* (Source: Ferrell Jenkins, <http://ferrelljenkins.wordpress.com/2010/08/24/the-watchtower/>.) and b) a typical stone agricultural watchtower of the West Bank hill country (color figure available online).

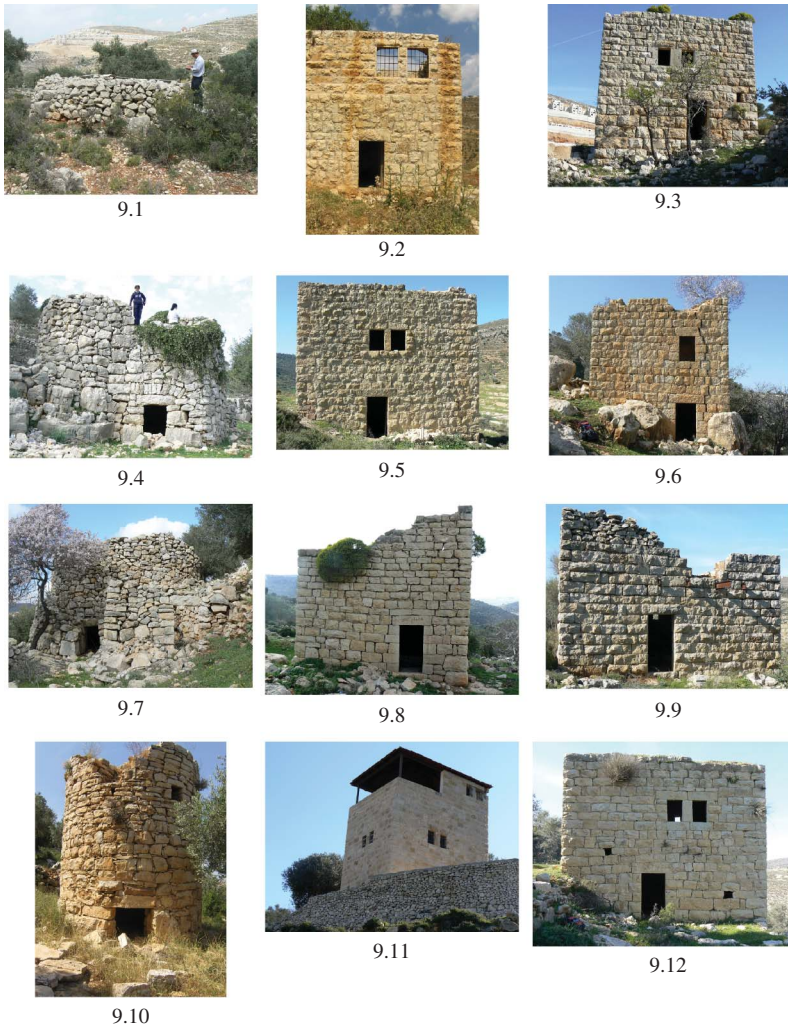
Figure 9. Photographs showing views of the twelve watchtowers that were fully surveyed and documented to facilitate the analysis of watchtower architecture in the study area (color figure available online).

had a thickness of 0.80–1.0 m. Quantities of water were then poured over the foundation areas in order to fully clean them of any accumulations of dirt that might interrupt the seal between the bedrock and the mortared stone foundation. Next, a layer of mortar was laid down, and on top of it parallel running courses of ashlar stones around the perimeter, defining the inner and outer wall faces and taking into account the placement and size of the external entrance. Once the lowest courses were laid, the space in between was filled with a combination of earth with lime, ash, and straw, and small to medium stones, all collected from the adjacent area. Proceeding upward, this method was repeated course by course until reaching the level of the ground floor roof. The exterior wall face was built with a relatively vertical profile, while, again, the internal faces inclined gradually inward beginning at a height of 0.8–1.0 m above ground level. At the top, the inclined wall face formed a vaulted ceiling, which ordinarily had the shape of a barrel-vault or cross vault or in few cases a hemisphere or dome. Subsequent storeys would follow the same steps, proceeding upward, until the building was completed. The masonry of these constructions (in contrast to the round towers above) consists of large, well cut and sometimes nicely dressed ashlar stones, laid in regular, horizontal courses, but which sometimes varied in height from one course to the next, dictated mostly by the available stone material (Figures 9 and 10c).

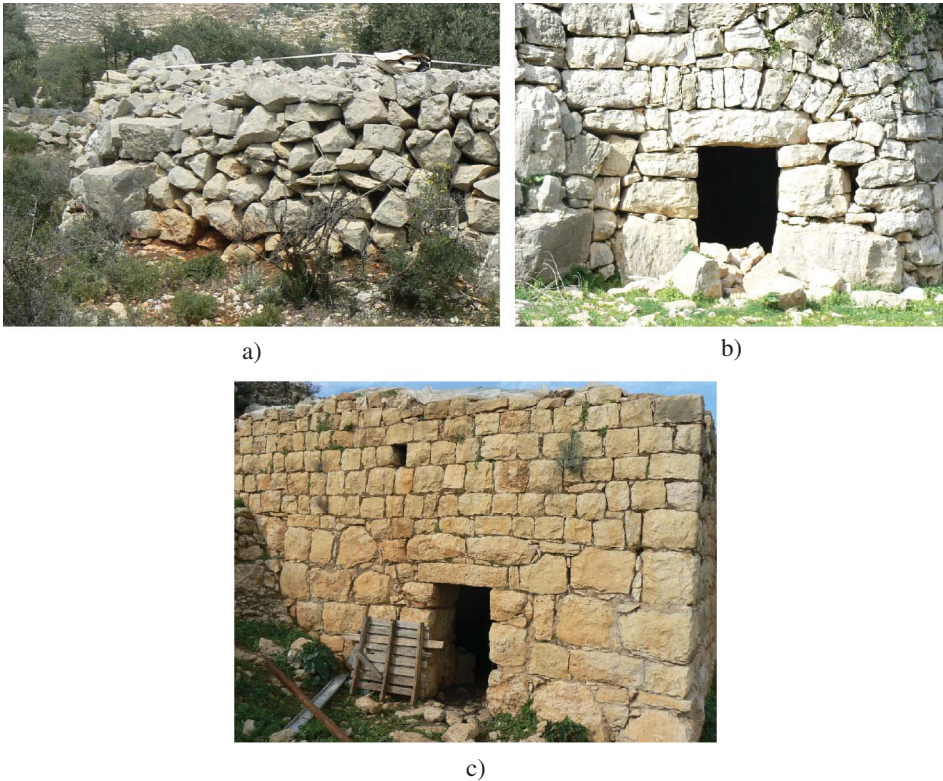
Figure 10. Photographs of the three categories of watchtowers in the study area, showing especially the texture of the stonework and the dimensions of the stones in each; the distinctive styles are most evident in the lower courses and around the door openings: a) a rounded stone heap, b) a corbelled stone watchtower, and c) a quadrilateral dressed ashlar stone watchtower (color figure available online).

5.2.1. Solid stone heaps The first technique is associated with the solid stone heaps. In this process, a single ring of large stones was used to outline the outer boundary and then the entire internal area was filled solid with stones of various sizes; these were mostly gathered from the site in the course of preparing the land for cultivation. This technique was repeated—a round course of facing stones, which was then backfilled—until the required height was reached. The external profile of these structures featured a slight inward slant proceeding upward, to ensure the necessary stability of the heap (Figure 10a).

to minimize the weight borne by the foundation (for more information, see Juvanec, 2003). The internal faces of the same walls likewise incline gradually toward the center; however, beginning approximately 0.8 to 1.0 m above floor level, ultimately forming a vaulted (or domed) ceiling; this ordinarily had the shape of a barrel-vault or cross-vault (or, in a few cases, a hemisphere). Once the ground floor was complete and roofed, this procedure could continue upward in the same manner until reaching the desired number of floors and overall height. Note that here it is hard to speak about *courses* of laid stone, since the stones are unworked and irregular in form, making it difficult to lay them in regular, horizontal courses or layers. Instead, they are simply fitted together according to their natural shape, but with the stones of the lower parts generally of larger size than those of the upper (Figure 10b).

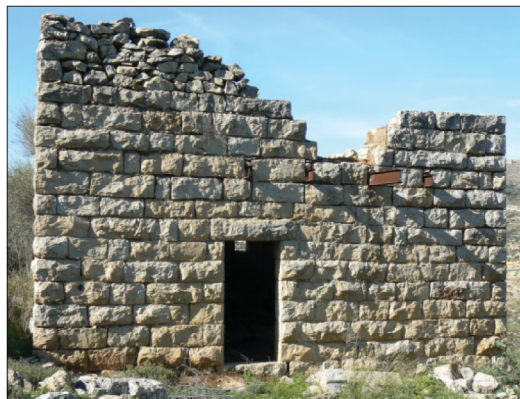
Figure 13. Drawings and a photograph showing a watchtower with a flat ceiling constructed of iron I-beams and cement: a) plan, elevation and section for a quadrilateral watchtower, with dressed ashlar stone and mortar and b) front view, with main entrance. Note the protruding iron beams, which probably supported a small upper-level balcony (color figure available online).
